Humming, droning noises and/or vibrations in propeller shaft

Topic number	LI41.10-N-071526
Version	1
Function group	41.10 Propeller shaft
Date	07-23-2020
Validity	Model 907.#53 ## with code IR4 (wheelbase 3665 mm) and with code IT5 (5.0 tonne)
Reason for change	Part changed
Reason for block

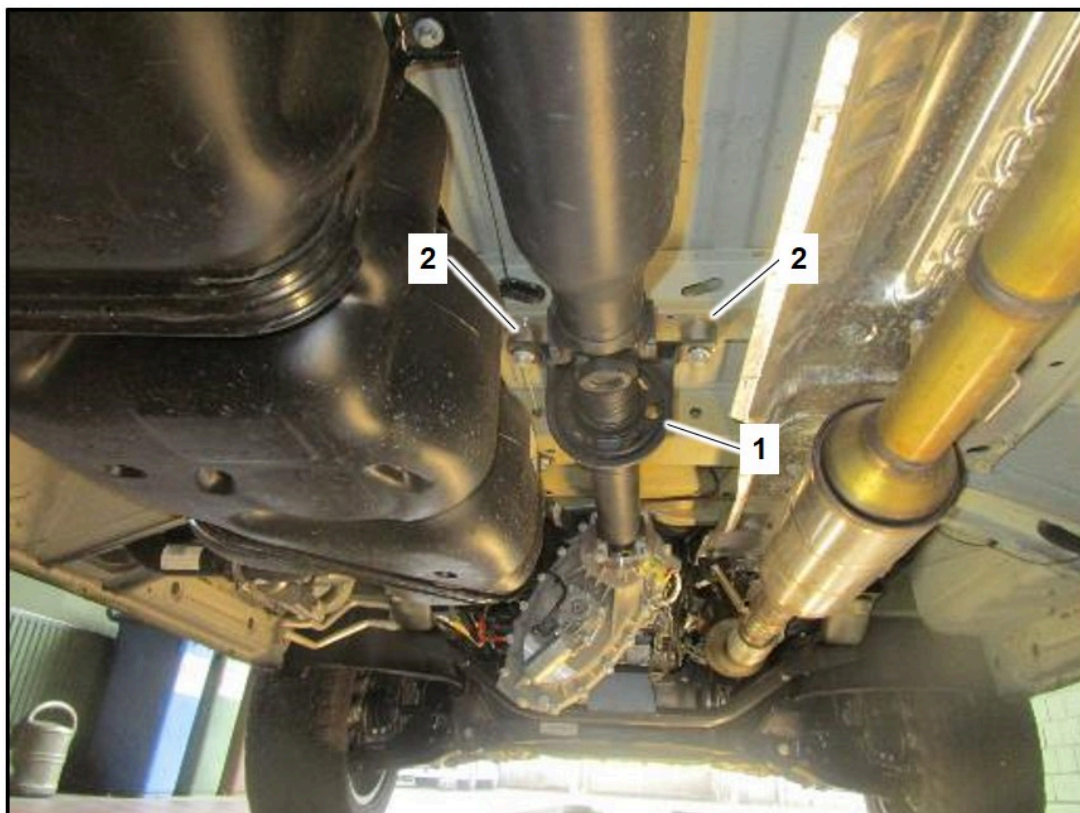
01.jpg:

Incline angle of propeller shaft not optimally adjusted.

Attachments	
File	Description
01.jpg	Change incline angle at propeller shaft intermediate bearing (1) using new 15 mm spacer disks (2).

1. Change incline angle at propeller shaft intermediate bearing (1) using new 15 mm spacer disks (2). To do so, detach the relevant propeller shaft intermediate bearing (1) from the vehicle floor (see picture 01 and AR41.10-D-0050TS).

Information: It is strictly essential to ensure that the existing spacer disks on the propeller shaft intermediate bearing (1) are not installed again.
